TECH-TIP

**Service Call:
Front and/or rear side marker
lights have become detached
from their covers.**

**RL4 With Vertical Mast
from SN RL415-101 to
RL416J-1082**

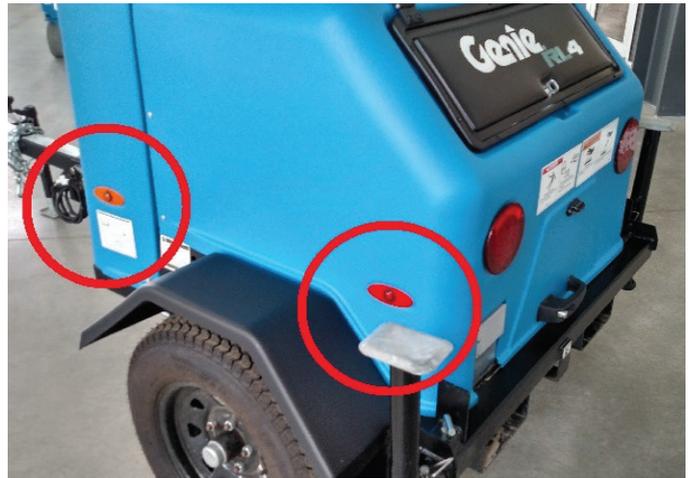
There is a possibility of the covers becoming detached from the marker lights over time. If this happens, there is a kit which should be installed which will fix the issue and prevent it from happening again.

Order kit 1270634 - Marker light kit.

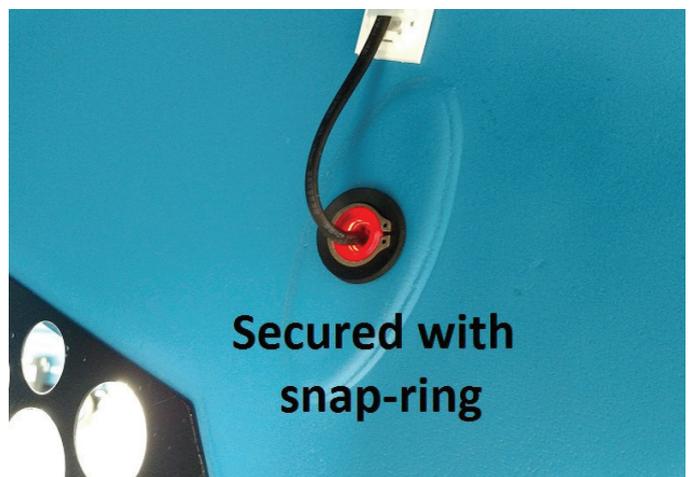
The kit comes with the instructions, light assemblies, washers, cable ties, and the snap rings that will secure the covers to the light assemblies.
